# CASE STUDY

## VERTECH GROUP

# ANGEL FLARE TIP REPLACEMENT

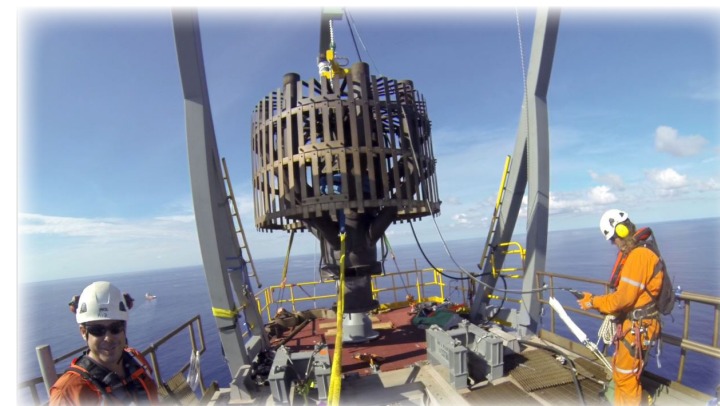
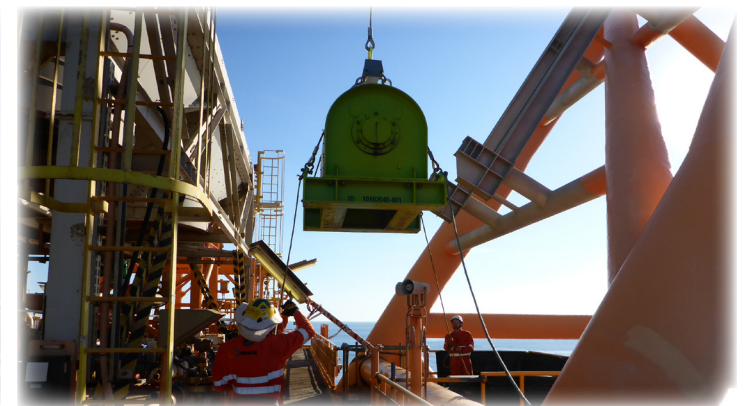
Vertech crews established initial access using rope access systems, to install the trolley to the flare boom. Additional preparatory works were required for the travel path of the 40t winch wire, which were all conducted using rope access. The 40t winch wire was reeved through a sheave cluster at the top of the flare boom using a 2 tonne daughter winch. The winches were installed during initial site set up before the facility shut down. Once the winch was function tested the platform has hauled to the flare boom top some 80 metres. The flare tip in its

awkward orientation was required to be restrained during its removal lift to mitigate the unknown centre of gravity and to control the load at all times. The riggers released lever hoists from tie down points as the tip was lifted using a pneumatically operated 7 tonne chain hoist. Once stabilised on the transport cone, the entire trolley was disengaged from the flare tip platform and lowered to the flare boom base. Here the old tip was removed and the new tip loaded. The trolley was system was again hauled to the top for the installation of the new flare tip. Once complete the trolley was lowered and disassembled to be back loaded to the beach. These works were delivered with a team of 9 over 3 weeks, consisting of the following skilled technicians:
