CASE STUDY

CAPE CUVIER JETTY REMEDIATION

INTRODUCTION

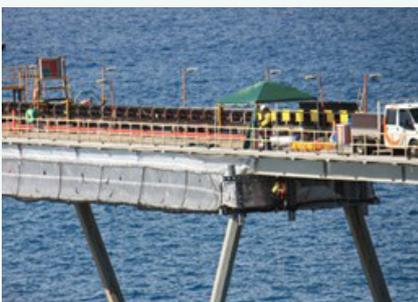
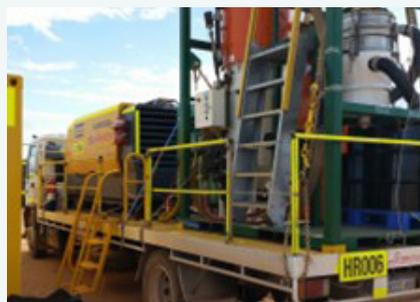
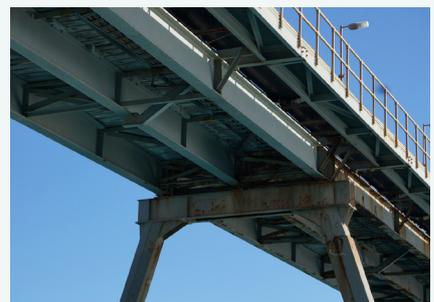
The WEB Deck system created a fully encapsulated, safe working environment that enabled blasting and painting tasks to proceed without risk. Its rolling front design ensured consistent progress, while its structural configuration distributed weight across pylons—avoiding load on the compromised understructure of the jetty. For coating remediation, VerTech used Sponge-Jet technology with a self-contained vacuum recovery system. This allowed reusable blast media to be recycled on-site, while safely capturing lead-contaminated waste in sealed 204-litre drums for licensed disposal.

The tailored WEB Deck access solution maintained the structural integrity of the jetty and ensured environmental safety. Airborne contaminant levels remained well below national exposure standards throughout, with zero impact on operational activities. The project was completed without incident or production loss, delivering a safe, efficient, and environmentally responsible outcome for the client.
